# CASE STUDY

## Stopping Gushing Pipe Leaks Using Single-Component Polyurethane Resin

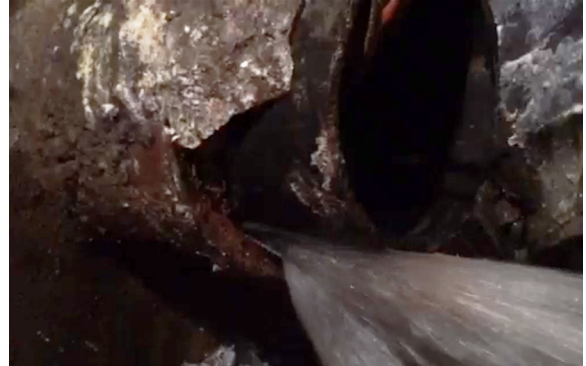
The space between the slipline and host pipes had active leaks that, according to the municipality's flow monitoring, were contributing an additional 3.5 million gallons per day (MGD) to their wastewater stream. To put that into perspective, that's more than enough water to fill five Olympic-sized swimming pools.

This still image from an on-site video shows the severity of the leaks.

**SOLUTION:** The repair was completed in six days using chemical grout from Prime Resins to seal the annular spaces in the seven slipline sections. The project required roughly 100 gallons of Prime Flex 920. After some trial and error on the first section, the method was perfected and subsequent sections were completed in a fraction of the time with less material. "This particular project was an engineer's worst nightmare to develop a permanent solution to stop the leaks at the manhole connections," said Gadsden Water and Sewer engineer Brian A. Purcell. "With the help

**HOW THEY DID IT:** To inject the polyurethane resin, Precision Chemical Grout used 10-foot sections of ½-inch PVC pipe as a probe connected to an F-valve. This allowed for standing in the invert and pushing pipe 10 feet up into the annular space, typically installing two PVC pipes for each of the leaking pipes

sealed—one at 4 o'clock and one at 8 o'clock to ensure grout would fully fill the annular space between the slipline and host pipe — packing open space with towels or sandbags to contain the resulting foam.

**BENEFIT:** The leaks were completely sealed in six days, ending the 3.5 MGD leaks that had existed for several years with a modest investment.
